Safety Alert
MEWP
Information from France

Circumstances	Thorough Inspection of a JLG brand, 860SJ type Movable Elevating Working Platform
Consequences	Potential serious accident (including fatality)

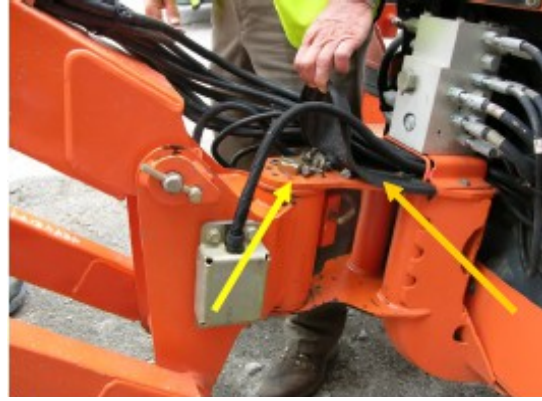
- When performing a detailed inspection of two JLG 860SJ movable working platforms, sheared bolts were discovered in the ***swivel area of the basket supporting boom***.
- The existence of a rubber cover plate makes such identification difficult when performing routine daily inspection.

Cover plate and sheared bolts

- Identify any JLG, type 800, platform (MEWP) in use at your sites.
- After removing the relevant cover plate, in accordance with the manufacturer's maintenance manual, carefully inspect the fittings to identify:
 1. Any sheared bolt
 2. Corroded bolts
 3. Damaged bolts
- In the case where any damage is identified, the platform should be taken out of service. The vendor, hirer or/and manufacturer should be informed of the findings.

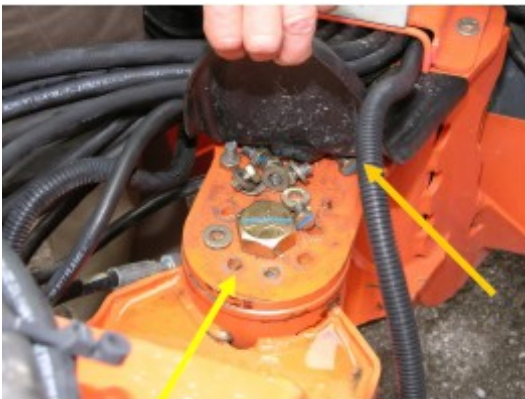
Sheared bolts

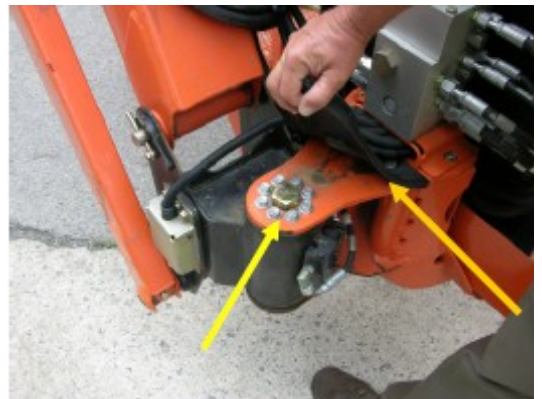
Replaced bolts
