1 Main bell wire rope damaged

2 Main bell wire rope failed destructive test

3 Lone worker collapsed at onshore site

4 A reminder on watertight doors

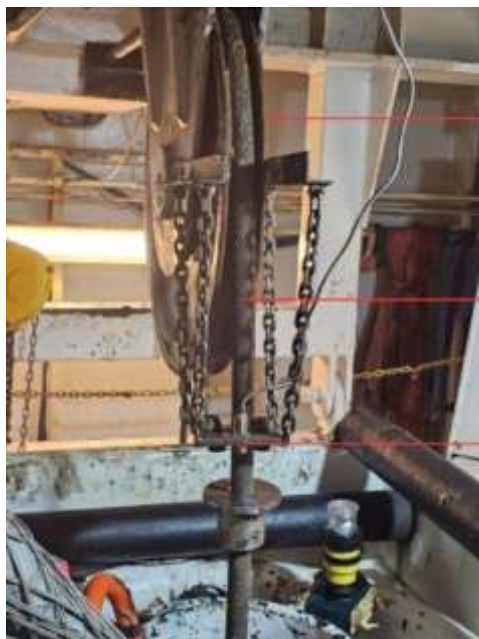
At the end of a saturation dive, a main bell wire was damaged by the proximity switch bracket (chandelier) being picked up by a single broken strand on the main bell wire rope. The incident occurred during a bell recovery procedure performed by the winch operator. The Moonpool operator stopped the winch operator from further recovery of the bell after noticing that the proximity switch bracket (chandelier) was in the bell launch and recovery sheave. Dive technicians freed up the chandelier from the sheave, and the bell was safely recovered.

A single outer wire rope strand, broken from the bell main wire rope, lifted the chandelier with the proximity switch into the bell main wire rope sheave.

- **Root cause of the incident: Failure of design.** The chandelier was a tight fit which allowed movement when the broken strand passed through. The bell main wire rope ran through a narrow space within the chandelier allowing a single broken outer strand to be caught up.
- **Direct cause of the incident: Equipment damaged.** A single outer strand broken from the bell main wire was enough to lift the chandelier with the proximity switch into the bell main wire rope sheave.

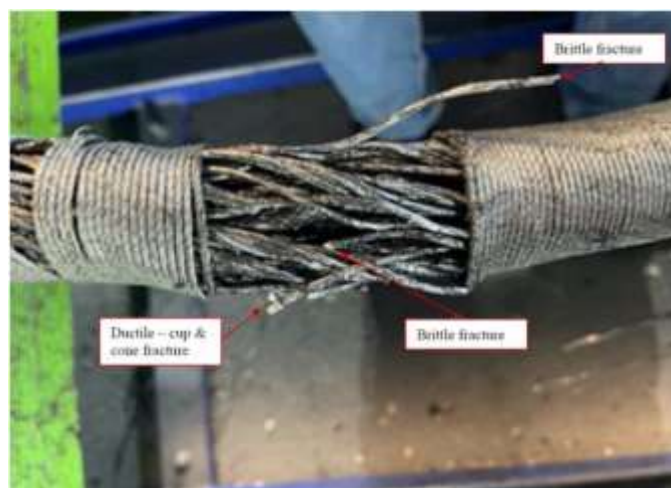
Showing fracture point of destructive test

The scheduled maintenance annual breaking load test completed in October 2022 achieved a breaking load of 99.9 tonnes (980 kN) 30% below MBL. In accordance with IMCA guidelines, a second test was permitted and achieved a breaking load of 108.6 tonnes (1065 kN) 24% below MBL.

From the review of the wire fractures at the rope destruction test, it was apparent there was a number of shear fractures present indicating poor ductility. A reduced ductility was also apparent following individual wire testing as part of the investigation. Component wires of reduced ductility cause a lack of elongation in the complete wire rope, resulting in a reduced load bearing capacity.

The lack of ductility was explained by the phenomenon of strain aging, which is a change in steel microstructure leading to a change in wire properties including a reduction in ductility. The occurrence of strain aging is initially influenced by steel chemistry and manufacturing methods and is then dependent on a time and temperature relationship which can be influenced by storage conditions.

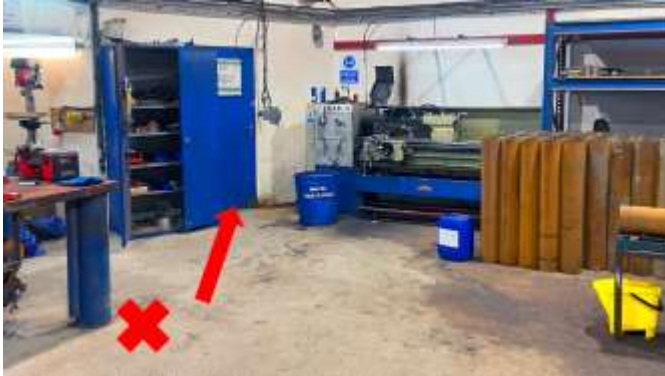
Workshop area: X marks the spot where the person collapsed

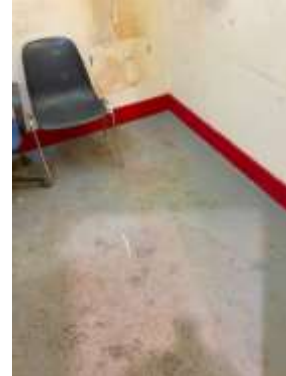
Disused office area to which the injured person was able to move

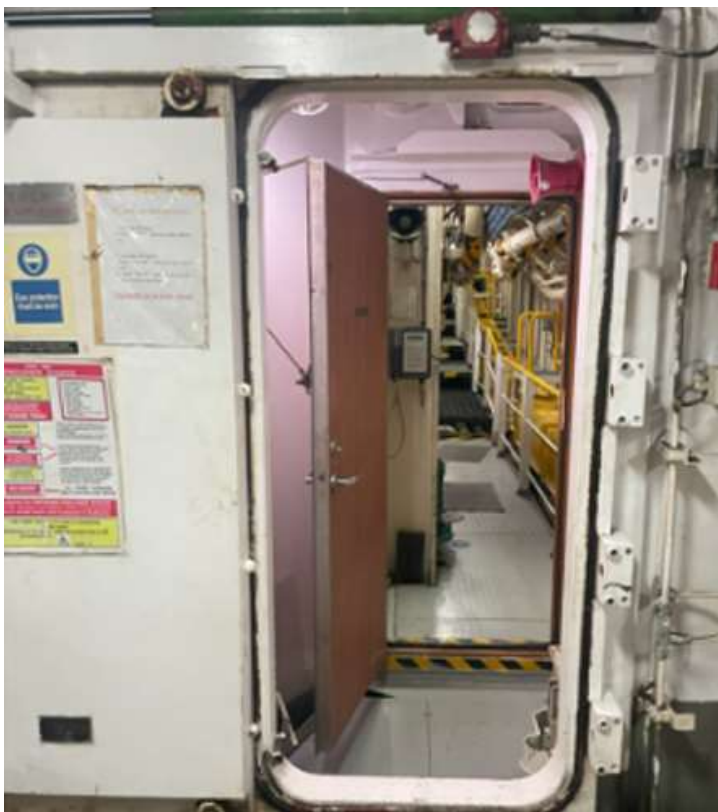
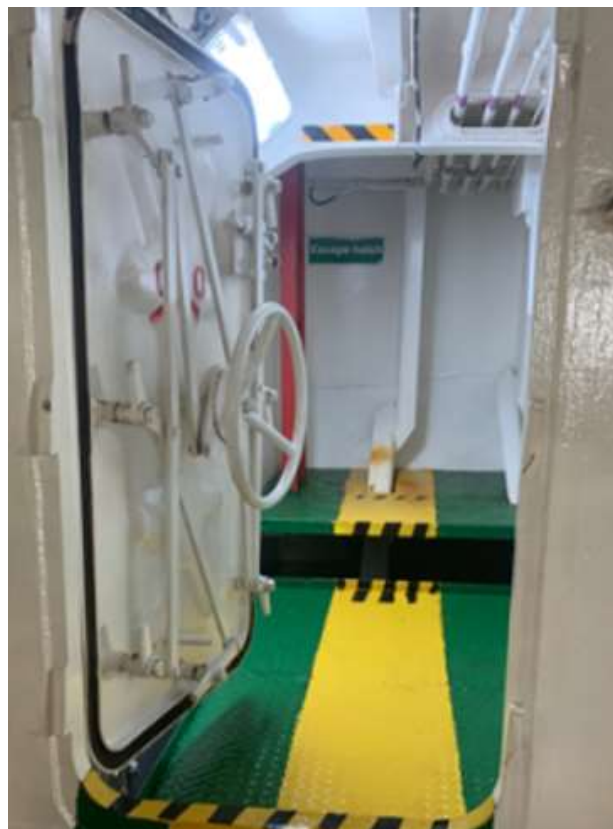
Watertight doors that ought have been secured shut, were observed open during a safety walkaround. It’s worth reiterating the importance of watertight doors – the clue is in the name. Watertight doors are special types of doors found on vessels, which prevent the ingress of water from one compartment to other during flooding or accidents, and therefore act as a safety barrier limiting the spread of water inside the vessel.

- It was noted, after further investigation during review of similar cases on two other fleet vessels, that watertight doors were left open after the regular engine room walk around, as this was a regular activity and there was “no point to open and close each time”;
- It was found that some crew were not aware of the relevant SOLAS and SMS requirements or the importance of keeping watertight doors closed at sea in case of emergency.
