1 Main bell wire rope damaged

2 Main bell wire rope failed destructive test

3 Lone worker collapsed at onshore site

4 A reminder on watertight doors

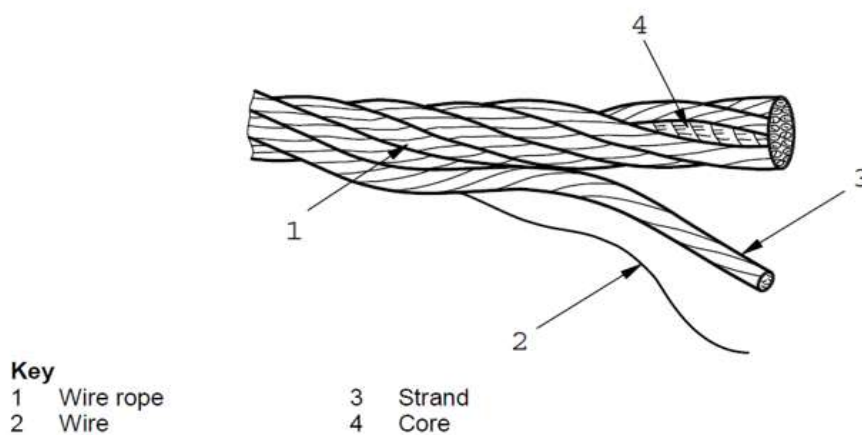
Components of a wire rope

IMCA notes: the above two flashes have been amended to reflect correct terminology with respect to the components of a wire rope: see diagram below. However, for purely practical reasons relating to internet links, the links to previous safety flash incidents relating to wire rope incidents, have not been amended.

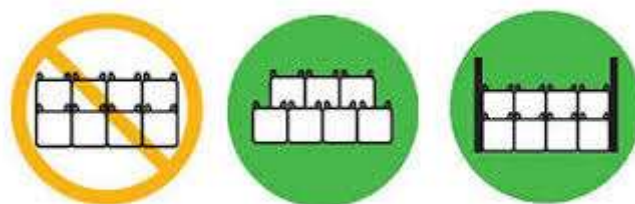
Image: <https://www.global-pak.com/fibc-safe-handling-instructions>

The HSE's findings were that the site was overstocked, bags of batteries had been stacked in an unsafe manner and there was no specific documented risk assessments or safe systems of work for the correct stacking and storage of batteries. This was not an isolated incident.
